**DOT/FAA/AR-95/13**

# **Structural Integrity Evaluation of the Lear Fan 2100 Aircraft**

May 1996

Final Report

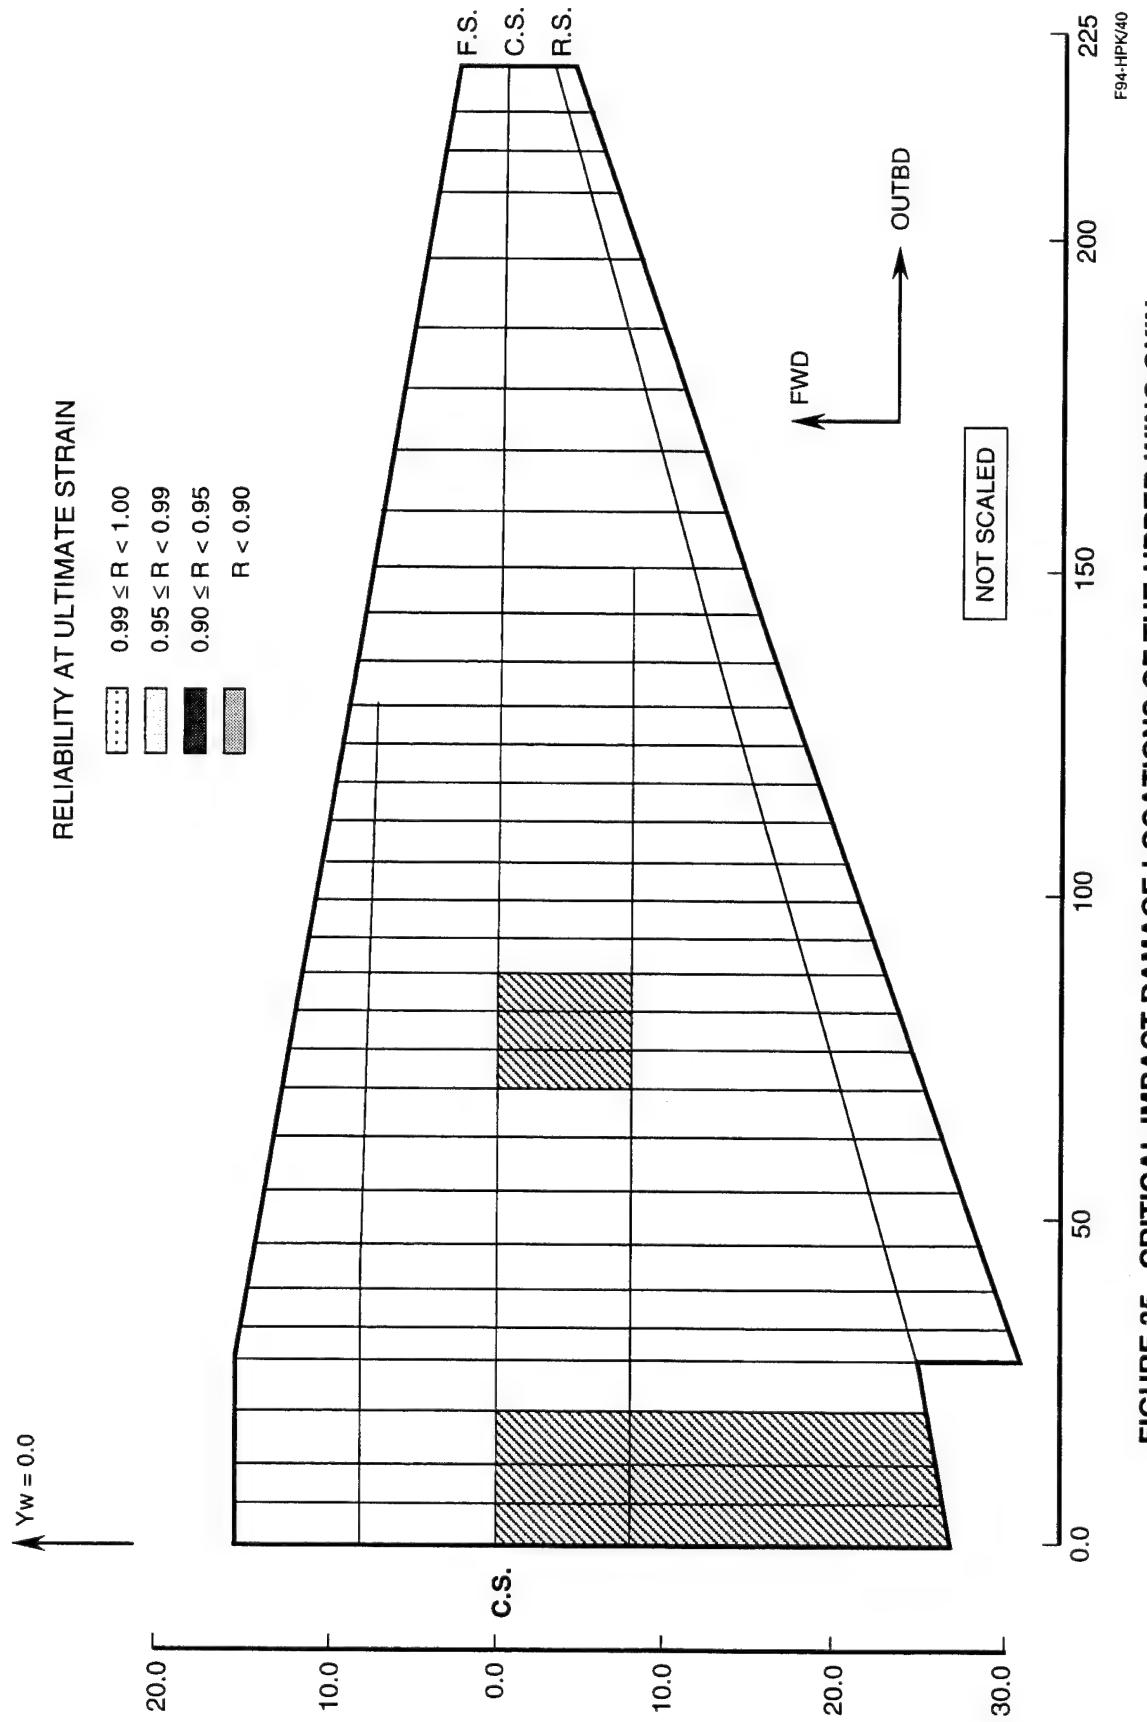
FIGURE 35. CRITICAL IMPACT DAMAGE LOCATIONS OF THE UPPER WING SKIN.

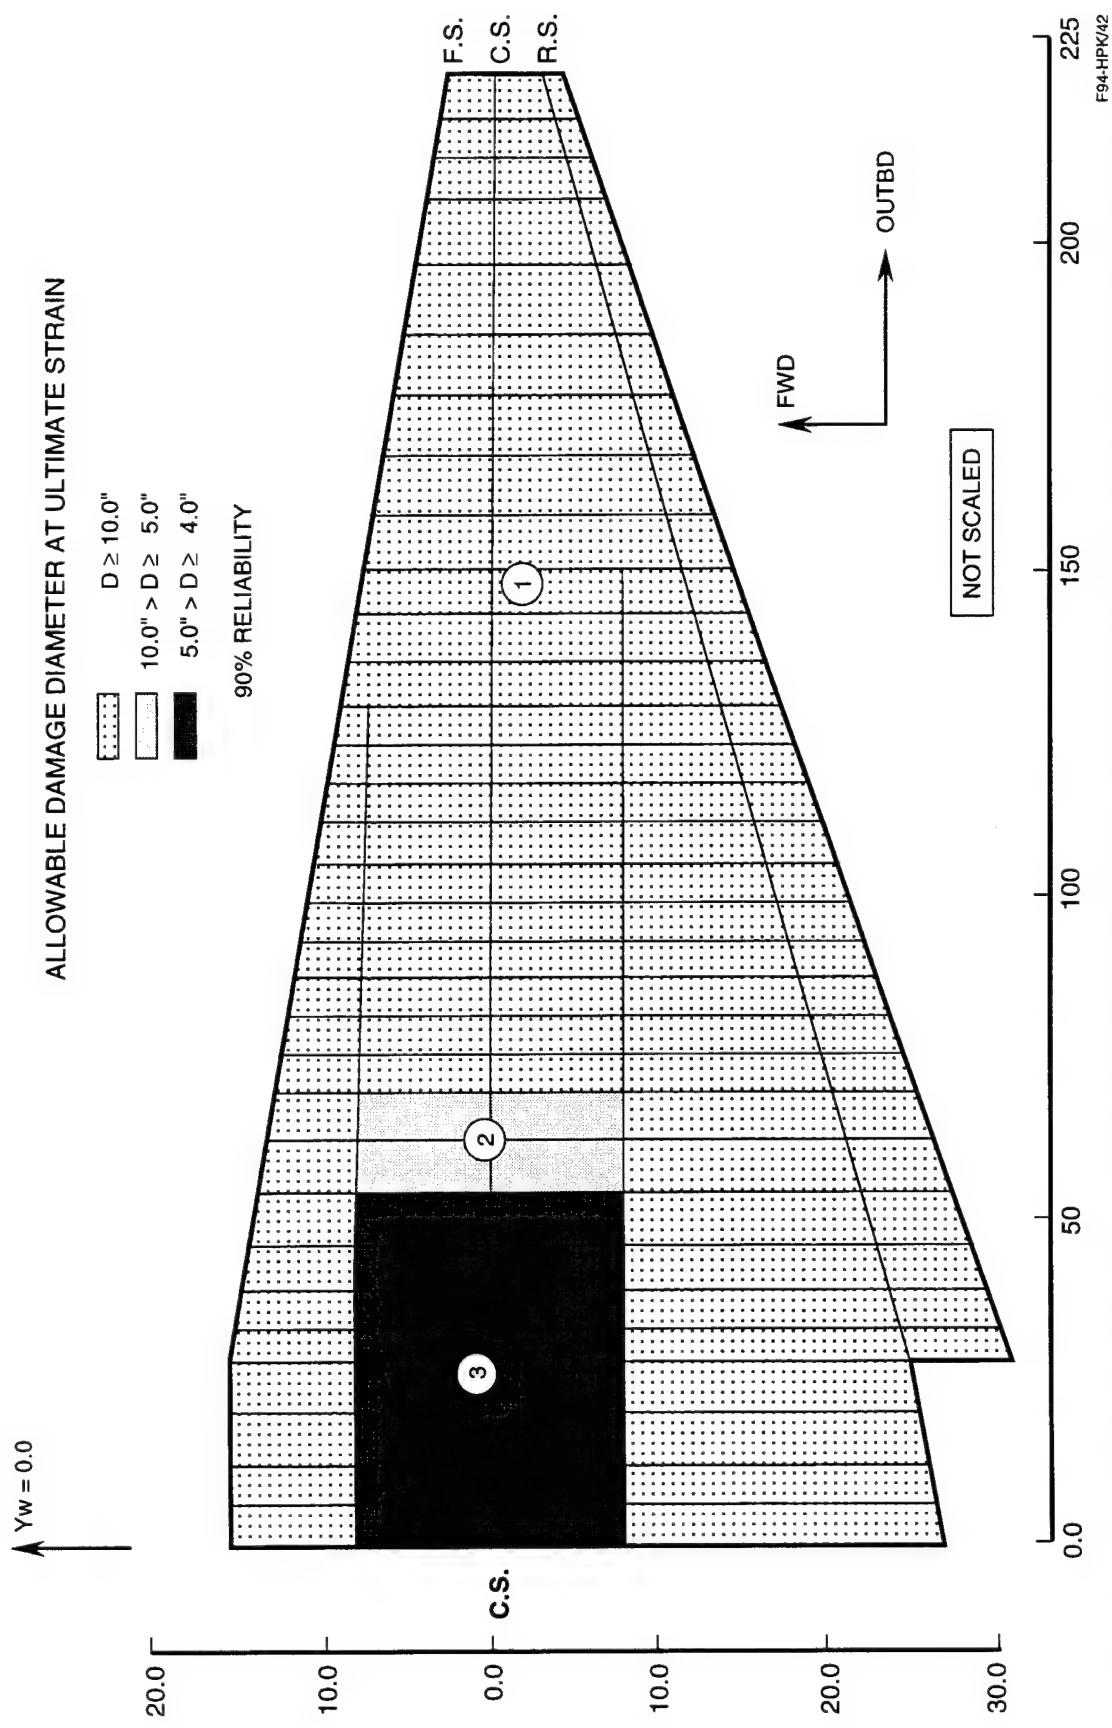
Tables 12 through 15 show the allowable damage size in the wing skin. Allowable damage sizes for 0.90, 0.95 and 0.99 reliabilities under maximum ultimate strains are shown in tables 12 through 14. Similar results for the skin under average ultimate strain are shown in table 15 for comparison purposes. Table 12 shows the results for the baseline damage scenario, that is for a stiffness retention ratio of 0.15. The results indicate that the allowable damage size is very sensitive to the reliability requirement. For the 0.90 reliability at ultimate condition, or the equivalent of a B-basis reliability requirement, the allowable damage diameter is large over the entire skin. The minimum allowable damage diameter is 4.045-in. which is considered to be a very rare damage scenario induced by the assembly processes. The distribution of the allowable damage size over the upper wing skin for this baseline case with 0.90 reliability under ultimate strain is shown in figure 37. The figure shows that the major portion of the wing skin can withstand damage larger than 10 in. in diameter. The minimum allowable damage size is between 4.0 and 5.0-in. located aft and forward of the center spar inboard of Yw 55.

As the reliability requirement is enhanced, the allowable damage size is reduced. This can be observed from the results shown in table 12. At the 0.95 reliability level, the minimum allowable damage diameter is reduced to approximately 1.0 in. in the region inboard of Yw 55 near the center spar. This critical damage size is further reduced to approximately 0.30 in. as the reliability requirement becomes 0.99 under ultimate condition.

**FIGURE 37. ALLOWABLE ASSEMBLY INDUCED DAMAGE DIAMETER IN THE UPPER WING SKIN, 90% RELIABILITY,  
 $S_r = 0.15$ , MAXIMUM STRAIN.**

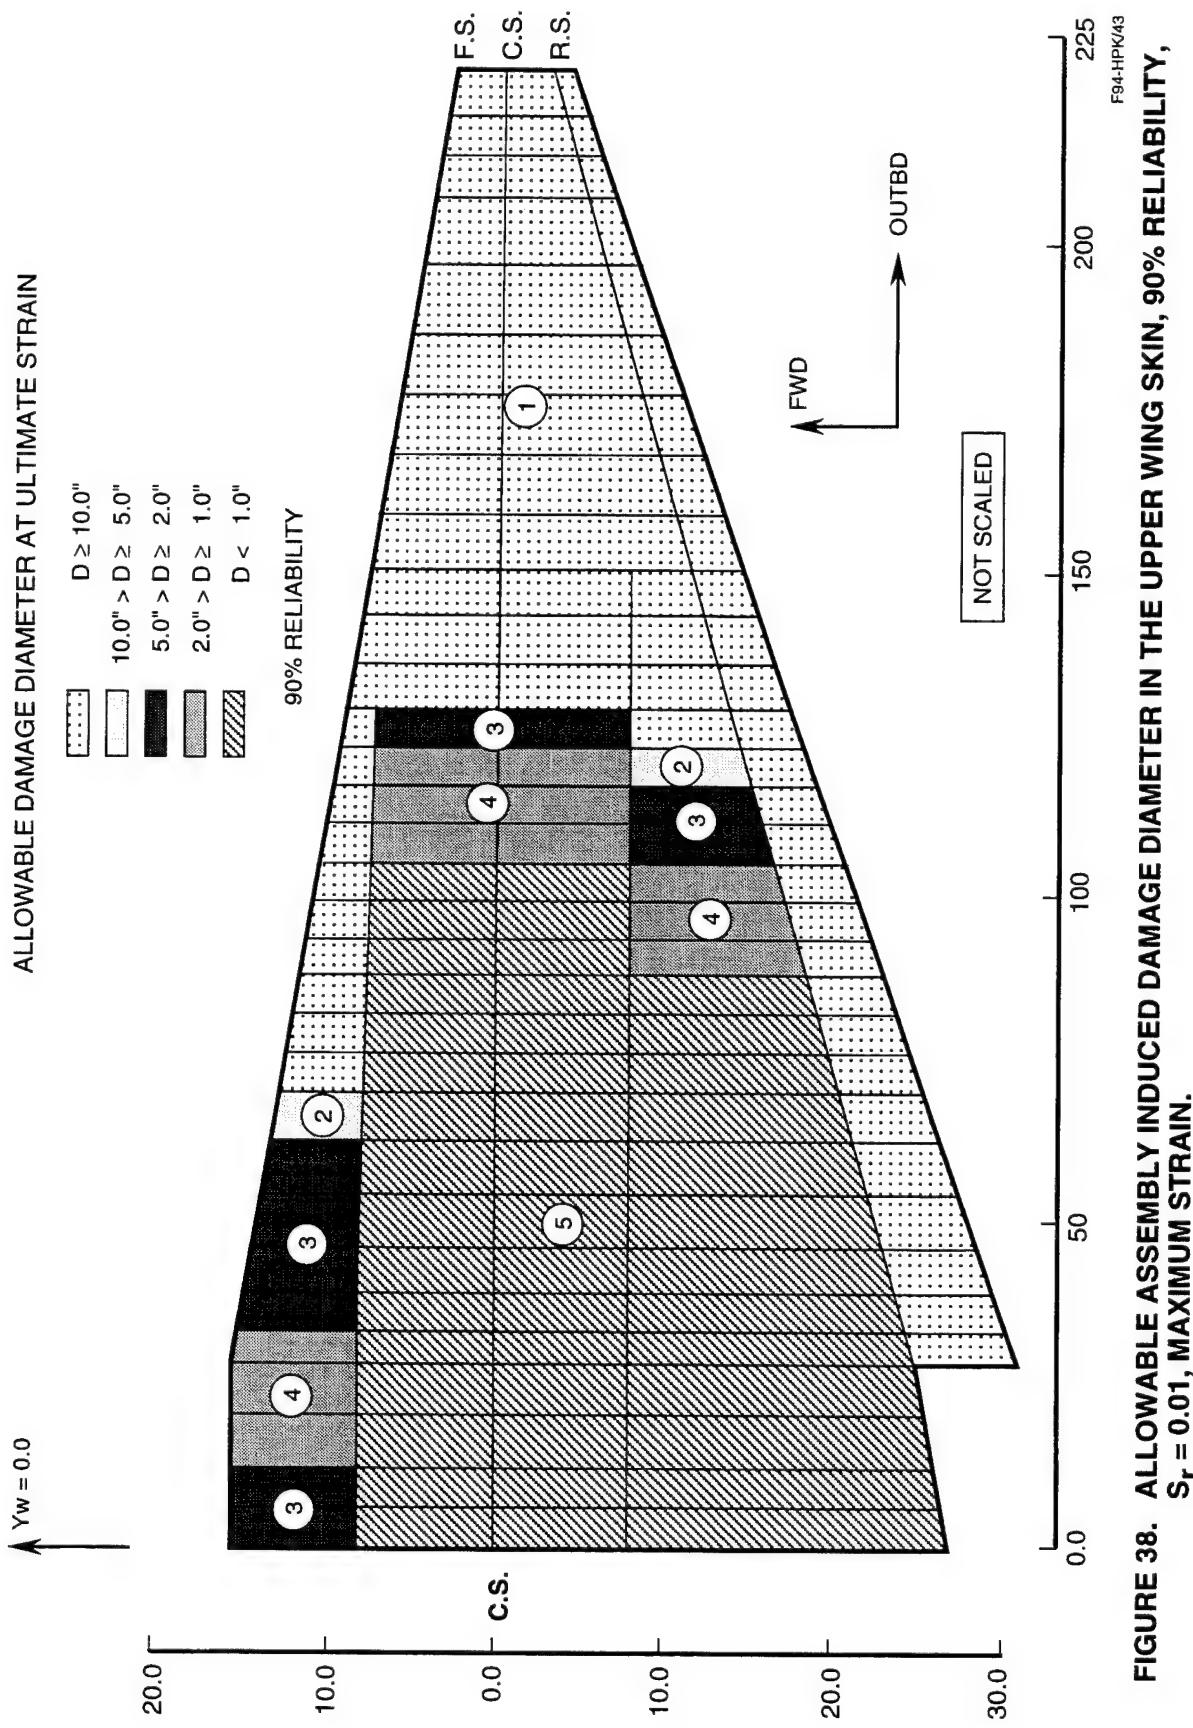
Similar results for reduced stiffness retention ratio are summarized in tables 13 and 14 and are shown in figures 38 and 39. Table 13 shows the results for a stiffness retention ratio ( $S_r$ ) of 0.01. This level of damage is usually induced by a poor assembly process due to severe overtorque or fastening composite parts with large un shimmed gaps. The results shown in table 13 indicate that the minimum allowable damage diameter is approximately 0.4 in. for the 0.90 reliability requirement in the most critical area of the wing skin. For a 0.99 reliability requirement, no damage of this type will be tolerated in the critical area, as the minimum allowable damage diameter is smaller than the fastener hole diameter of 0.25-in. The distribution of the allowable damage size is shown in figure 38. This figure shows that the allowable damage

**FIGURE 38. ALLOWABLE ASSEMBLY INDUCED DAMAGE DIAMETER IN THE UPPER WING SKIN, 90% RELIABILITY,  
 $S_r = 0.01$ , MAXIMUM STRAIN.**

size is still large in the wing tip area. However, the allowable damage diameter is smaller than 2.0-in. for a large portion of the skin inboard of Yw 123.

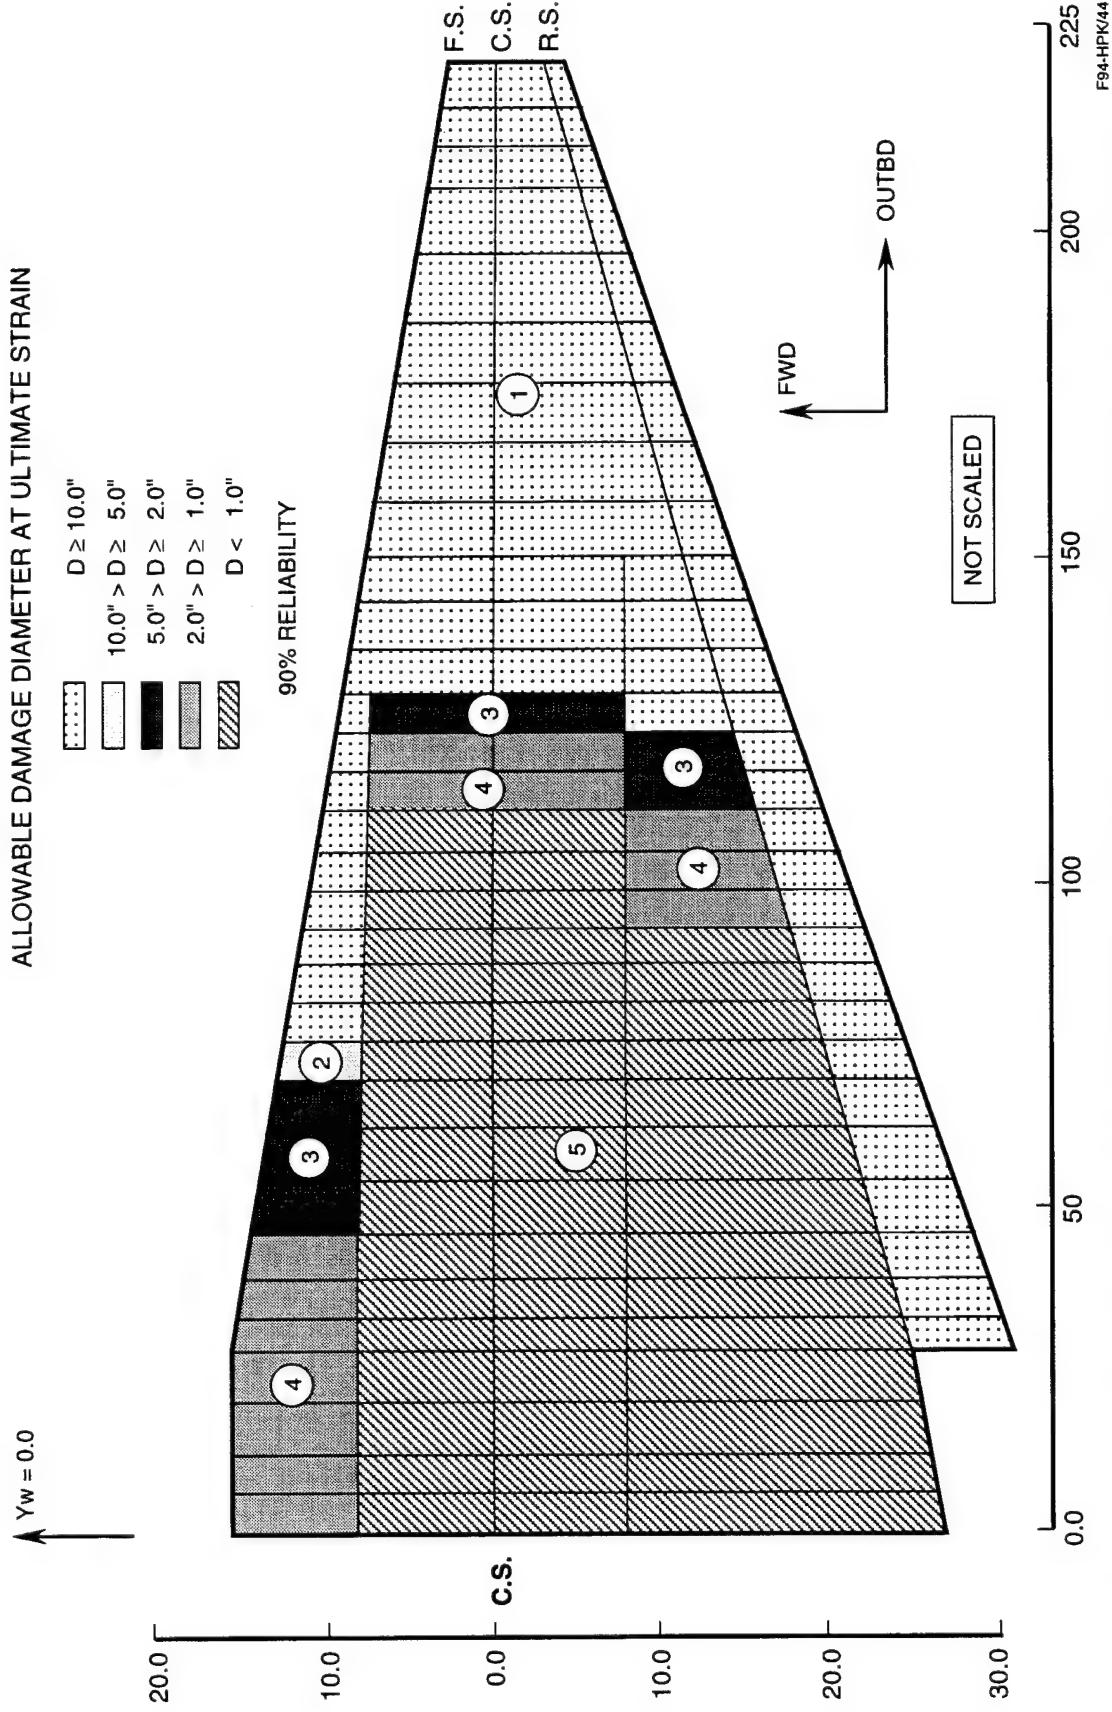
**FIGURE 39. ALLOWABLE ASSEMBLY INDUCED DAMAGE SIZE IN THE UPPER WING SKIN, 90% RELIABILITY,  
 $S_r = 0.001$ , MAXIMUM STRAIN.**

Table 14 shows results for  $Sr=0.001$ , which represents damage induced by a very poor assembly procedure with nearly visible fastener pull-through. As expected, the results show a very significant reduction in the allowable damage size in the critical locations of the wing skin. The minimum allowable damage diameter for a 0.90 reliability, is 0.375-in. in subdivisions 137 and 138. The 0.90 reliability damage size distribution is shown in figure 39. As shown in the figure, the allowable damage diameter is smaller than 1.0 in. for a large portion of the skin inboard of Yw 111.

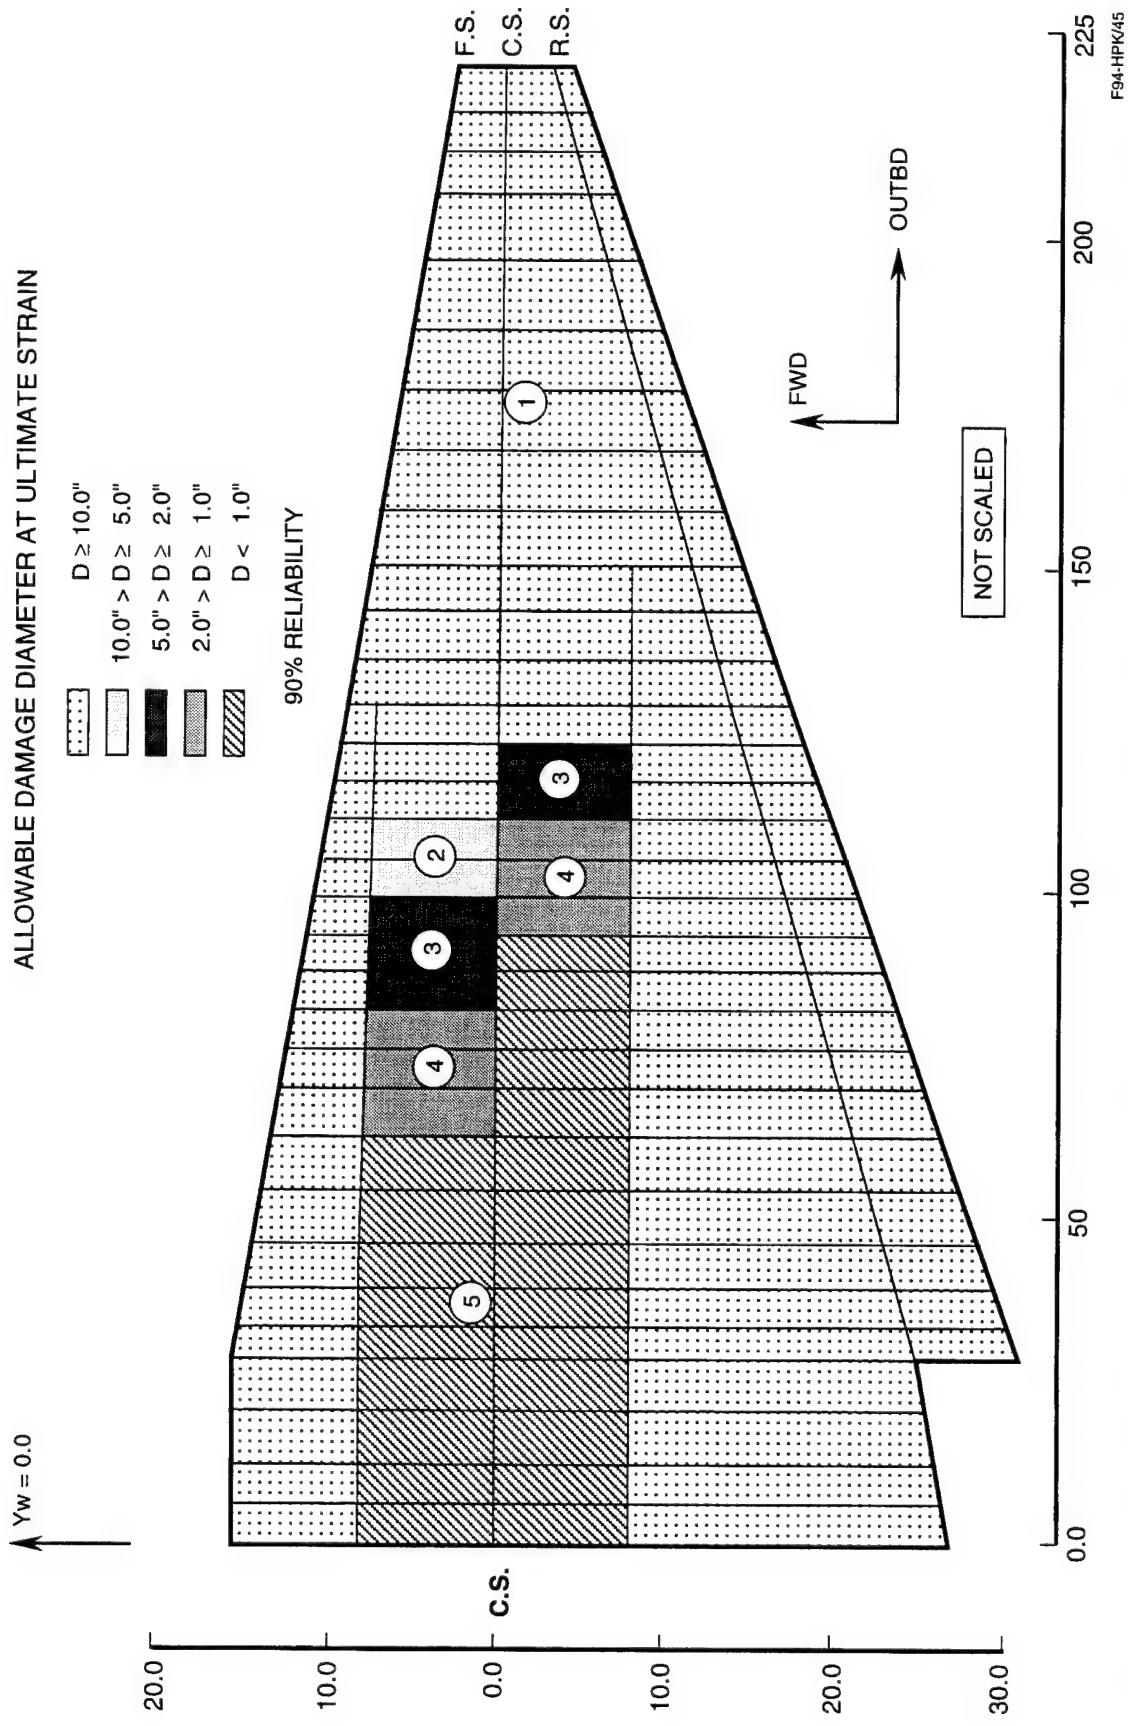
Table 15 and figure 40 show the results of allowable damage size for the wing skin under average ultimate strain in each subdivision with  $Sr=0.01$ , for comparison purposes. These results show that a large portion of the skin is capable of tolerating large size damage. However, the allowable damage diameter is smaller than 1.0 in. for portions of the inboard area near the center spar.

The results of the assembly induced damage tolerance evaluation for the Lear Fan 2100 upper wing skin show that the structure is capable of tolerating damage induced by normal assembly operation. This is evident by the defects detected on the E009 aircraft. However, NDI after final assembly is needed to assure that the structures are properly assembled, because the results of the evaluation indicate that poor assembly operation may degrade the integrity of the

structure. Local structural failure under ultimate strains may be initiated at locations with severe assembly induced damage.

FIGURE 40. ALLOWABLE ASSEMBLY INDUCED DAMAGE SIZE IN THE UPPER WING SKIN, 90% RELIABILITY,  
 $S_r = 0.01$ , AVERAGE STRAIN.
